Corrosion in the Flue Gas Cleaning System of a Biomass-Fired Power Plant

Published in:
Journal of Failure Analysis and Prevention

Corrosion in the flue gas cleaning system of a biomass fired power plant

Abstract

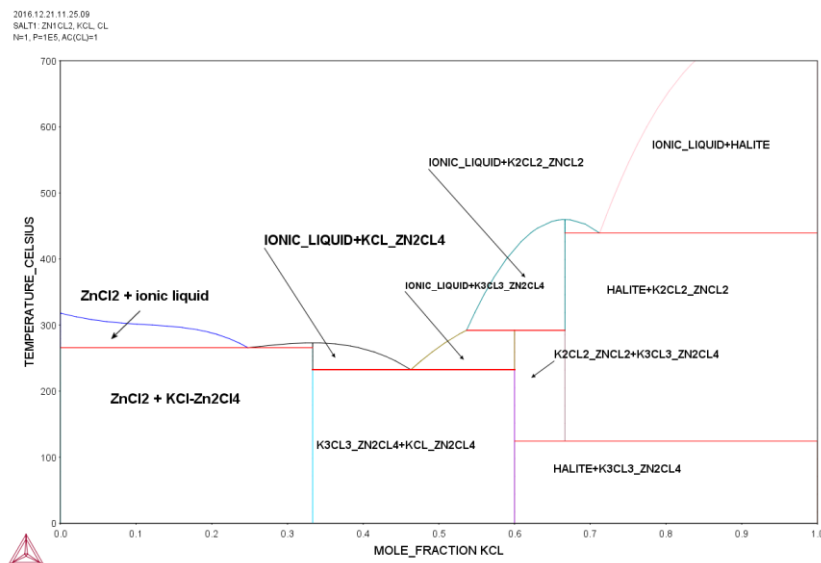
Analysis of deposits found in the duct after the DeNOx in the first few years reveals the presence of very hygroscopic Zn-K-Cl agglomerates. The fuel used in AMV1 is wood and straw pellets, and not demolition wood. From deposit analysis from the boiler, no Zn was found, and it was not present in the GGH. It is suggested that the presence of Zn-K-Cl agglomerates indicate that a reaction has occurred in the DeNOx between KCl particles from the flue gas and Zn containing primer used to protect the DeNOx components during construction. At 280-305 °C which is the working temperature in the DeNOx unit, KCl particles could react with Zn to form K-Zn-Cl volatile components, see Figure 12. These have probably been en-

trained in the flue gas and would agglomerate together at lower temperatures. Once the Zn coating has been removed from the DeNOx unit, this reaction will no longer occur, therefore these agglomerates were not observed in later years.

Figure 12: Eutectic molten salts of $KCl-ZnCl_2$ [14].
